FOCUS ON CONSERVATION

Cementing the Future

Repairing the concrete sculptures at the Charles Macdonald Concrete House Museum

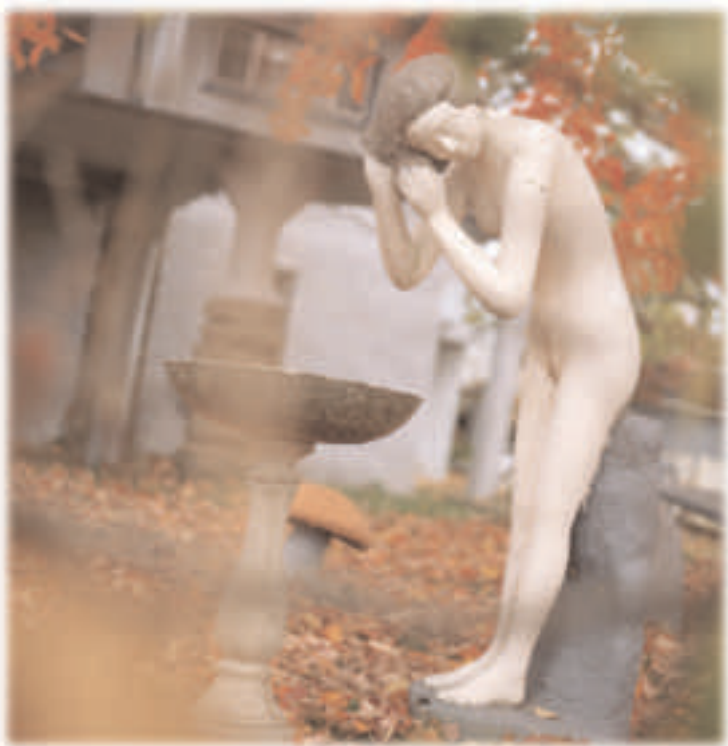
Left: Woman washing her hair. This was Charlie's favourite, and most controversial, sculpture.

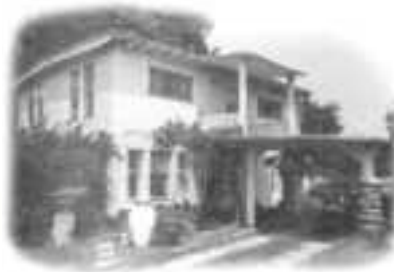
Above: The Charles Macdonald Concrete House Museum at 19 Saxon Street, Centreville, Kings County, Nova Scotia.

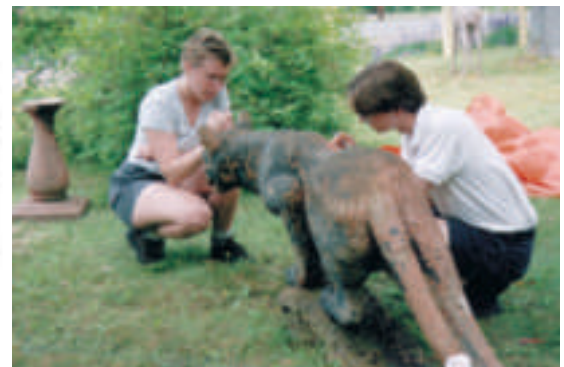
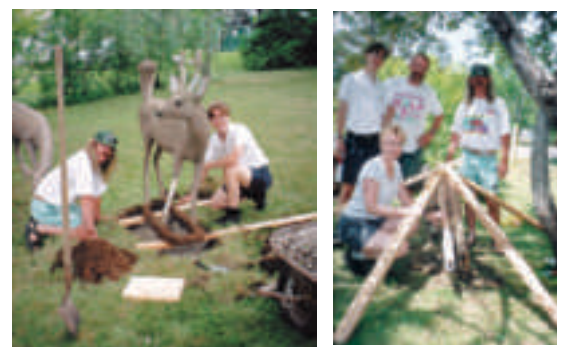
Top: Paula French and Robin Bates scraping paint from the concrete mountain lion. Bottom left: Kevin West and Robin Bates laying gravel beneath deer to stabilize and level. Bottom right: Stabilizing mountain lion. Standing L-R: Robin Bates, Jerry Cudmore, Kevin West. Kneeling: Paula French.

Gravel is more stable than soil and more conducive to water drainage, so it was used to level the ground beneath leaning statuary.

Next came the cleaning of the statues, accomplished with water, paint strippers, brushes, metal scrapers and dental picks.

Often concrete had worn away over the years, exposing the metal substructure. Where this had happened, the substructure itself had corroded and needed cleaning before it could support new concrete. To clean the exposed metal, conservators used metal scrapers as well as brushes with brass and nylon bristles.

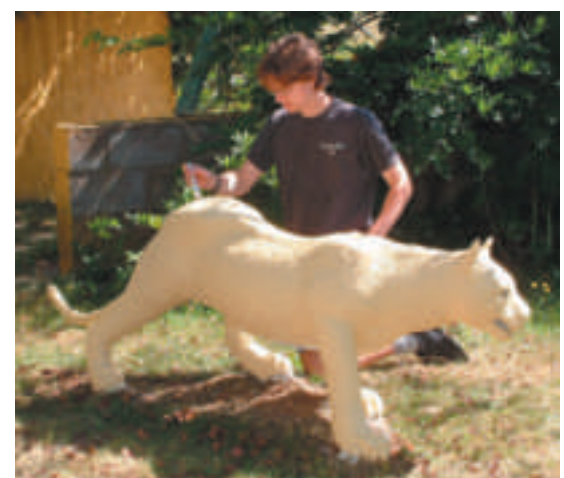
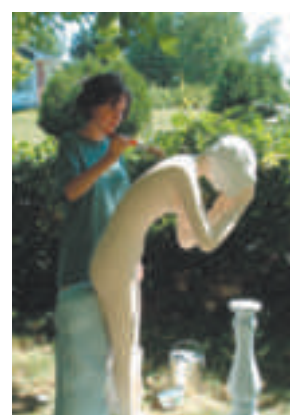
Above: Robin Bates applies the finish coat to the Mountain Lion. Left: Julie Gardiner repainting Woman Washing her Hair after repair and priming are completed.

Concrete must be protected at all times to prevent damage from water absorption. "A paint and primer combination is a suitable and affordable solution" says French. A primer coat was applied to the newly mended statues by the conservation team. The last step is to regularly re-paint the sculptures as Macdonald had them originally, preserving his works for the people of Nova Scotia.

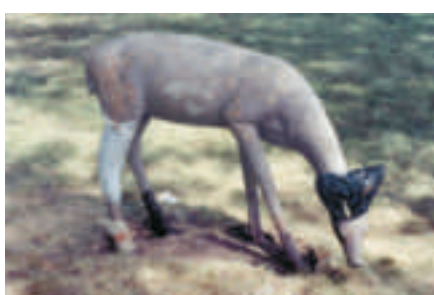
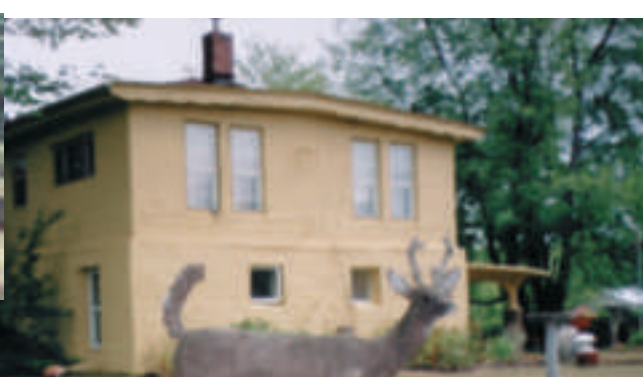
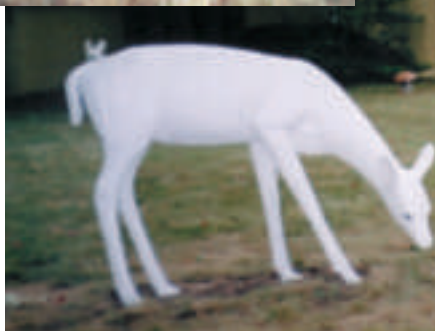
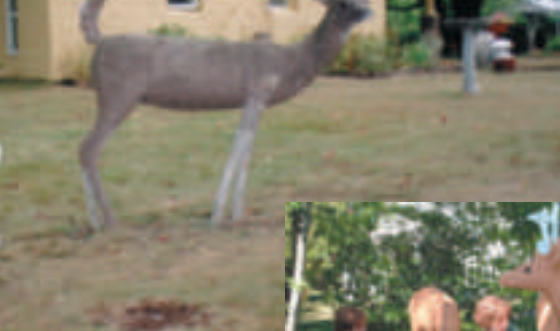
Two deer on the lawn of Macdonald House, one before (R) and one after (L) its conservation treatment. Top inset photo shows the doe's new concrete patches curing. Bottom right inset: Julie and Robin paint final coat on deer.

Conserving as much of the original material as possible is important, but often new concrete had to be applied where the old had fallen away. French used concrete patches to create a texture and consistency similar to Macdonald's own concrete. First she applied the new concrete with trowels and spatulas. Then the concrete fill was "manually manipulated to mimic the texture of the original material." Moistened towels and plastic bags made "casts" for the mended appendages, to keep the patches from drying too quickly and cracking.
